Subject: Annual Inspection Report
Haleyville Municipal (Posey Field) Airport

ANNUAL INSPECTION REPORT

HALEYVILLE MUNICIPAL (POSEY FIELD) AIRPORT

HALEYVILLE, ALABAMA

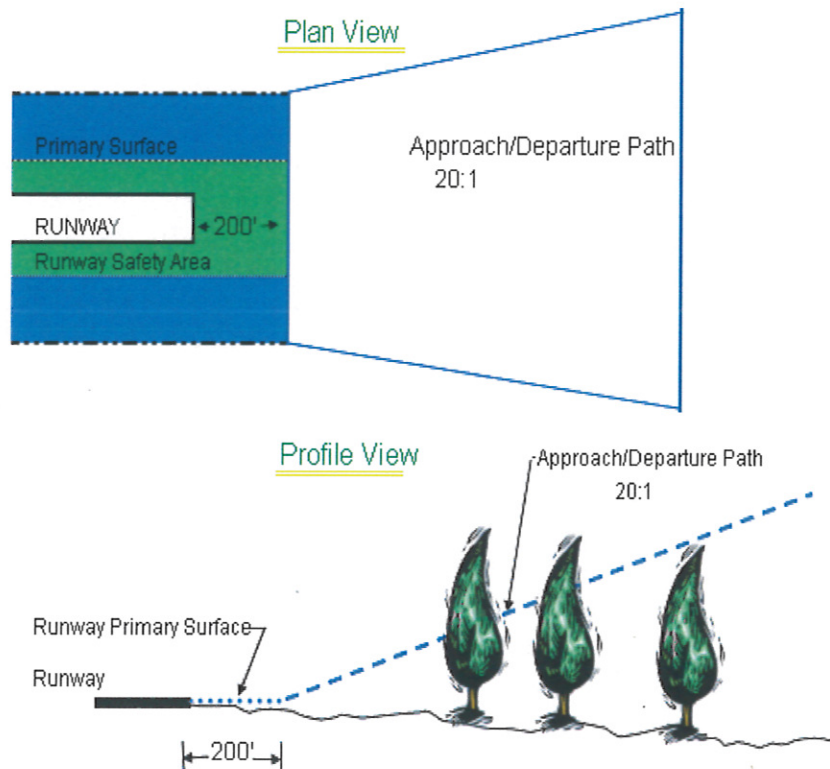
Appendix 1

- Runway 36: The approach and departure path for runway 36 was inspected and found to meet state licensing standards. However, trees identified as Tree # 3 , # 6 and # 7 violate the 20:1 approach slope within limits of the FAA's Runway Protection Zone (RPZ) and a tree identified as Tree # 4 AND # 5, if allowed to continue to grow will eventually penetrate the ALDOT 20:1 Approach/Departure Path (See Photo # 1, and Appendix 2).
- Runway 18: No obstructions (See Photo # 2 and Appendix 3)

- While the airport meets the state requirements, the violations to the 20:1 FAA approach slope within the limits of the RPZ for runway 36, as depicted on the most recent Airport Layout Drawing (ALD) dated August 2002 should be removed as well as the potential obstructions, before they become hazards.
